ARDS AND NORTH DOWN BOROUGH COUNCIL

**GILLESPIE MONUMENT
COMBER**

CONDITION REPORT

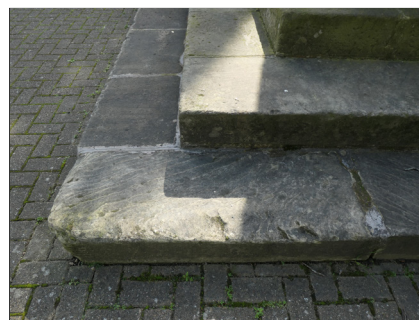
Fig.05 - Delamination to steps

Extensive decay and delamination to bottom steps to east and west ends (Fig. 05). Lime mortar patch repairs with possible cementitious content to nosing of steps to west end. Spalled edging to steps. Steps inadequately bed lapped with voids evident at bedding between steps. 2 no. replacement stone to bottom step (stone type not known). Widespread algae and lichen soiling (Fig. 06).

2. Undermined and heavily delaminated step to plinth should be replaced with a suitable stone replacement and any displaced stonework eased back into position.

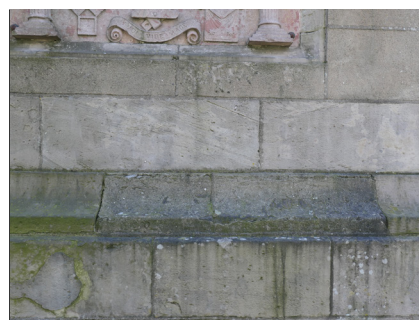
Fig.07 - Cementitious mortar repairs

Surface pitting throughout. Contour scaled delamination to 3 no. polished ashlar and minor delamination to moulded string course. Cementitious mortar repairs to 2 no. moulded string course and 1 no. ashlar stone (Fig. 07). Widespread algae and lichen soiling.

3. Cementitious render repairs – These should be removed and underlying stone accessed individually by a suitably qualified conservation professional for indentation repair or full replacement using a compatible stone type.

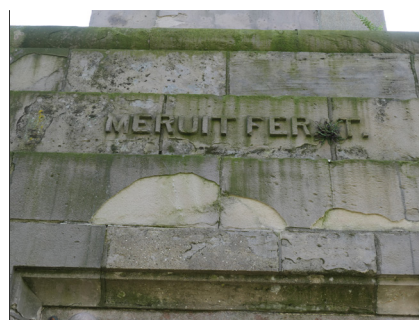
Fig.08 - Contour scaled delamination

Cementitious mortar repairs carried out to face of ashlar quoin stones to west end and to moulded border surrounding recessed panel. Extensive contour scaled delamination to ashlar stone to east end and above recessed panel with fractured stone evident (Fig 08). Widespread algae and lichen soiling.

4. Delaminated stonework – All delaminated stonework should be individually assessed by a suitably qualified conservation professional for possible retention in order to retain as much of the original fabric, through consolidation, stabilisation or full replacement. Heavily delaminated ashlar stone beyond repair should be replaced using a compatible stone type.

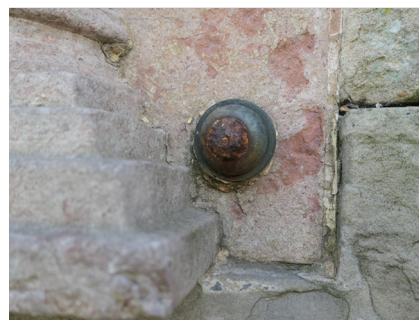
Fig.09 - Corroded metal fixings

Minor erosion to limestone relief carved tablet, metal fixings heavily corroded (Fig. 09), otherwise reasonable condition.

7. Limestone tablets – Relief carvings and incised lettering should be lightly cleaned and all fixings carefully removed and refixed with stainless steel fixings. Fractured panel should be repaired with epoxy resin. A low pressure lime based grout should be used to fill voids behind each tablet.

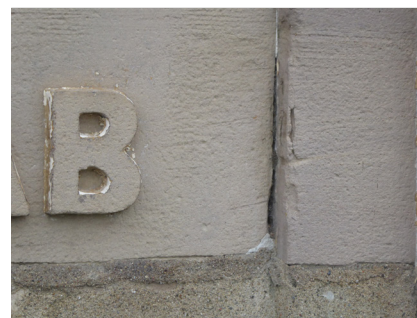
Fig.10 - Cementitious pointing

Open joints with inappropriate cementitious pointing throughout applied over original lime putty, joints widened during previous phase of repairs (Fig. 10).

8. All defective and inappropriate cement-based pointing should be raked-out using non-mechanical means and repointed using lime-based mortar. This will entail full repointing of the entire monument.

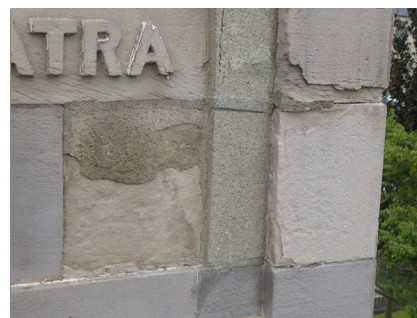
Fig.11 - Advanced decay

Inappropriate cementitious mortar repairs carried out to stonework to west side of inscribed panel, repairs cracks in mortar repairs and detaching from background. Advanced decay to west side of panel and directly below raised lettering (Fig. 11). Minor fissures to raised lettering.

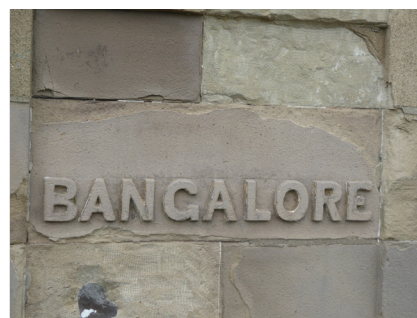
Fig.12 - Delamination

Entire panel in advanced state of decay with inappropriate cementitious mortar repairs carried out, mortar repairs failed and detaching from background and contributing to decay of surrounding stonework (Fig. 12).

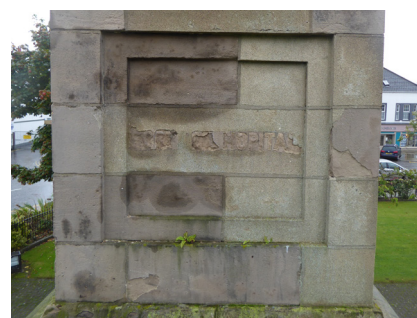
Fig.13 - Loss of raised lettering

Widespread inappropriate thinly applied cementitious mortar repairs, some detachment of mortar repairs resulting in complete loss of raised lettering and decay of surrounding stone (Fig. 13).

12. Missing raised lettering inscription could be addressed with new indentation lettering or left alone. Fissured and remnants of raised or incised lettering and relief carvings should be preserved by consolidation treatment in order to stem the weathering process. It is essential this work is carried out by a qualified specialist stone conservator.

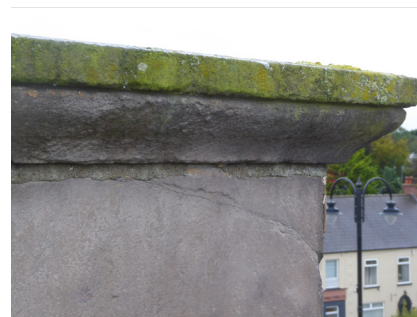
Fig.14 - Fractured stone

Heavy algae staining, fractured stone to west end (Fig. 14), previous indent repair to west end stone showing rust marks possibly indicating ferrous metal fixings used, minor erosion, otherwise reasonable condition.

11. All fractures and open voids should be grout injected. The grouting material should be compatible with the existing material and not impose any additional loading or change in composition due to thermal variations which may put stress on the structure.

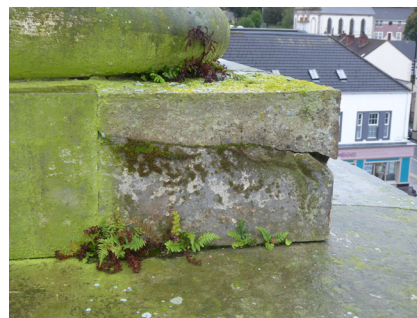
Fig.15 - Heavily fractured stone

Heavy algae staining, surface scaling on top surface, heavily fractured stone to north-west corner presenting a potential hazard (Fig. 15), otherwise stonework in reasonable condition.

1. Remove all dangerously loose stone as highlighted throughout the report.

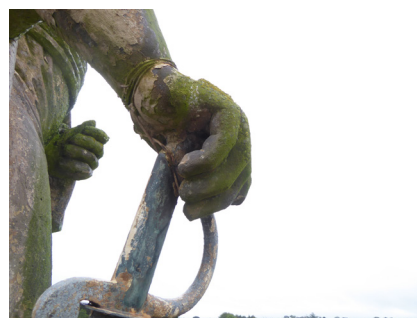
Fig.16 - Fractured hand

Heavy algae staining. Fractured right hand repaired using epoxy resin. Crude wire strapping applied as secondary protection around hand and sword (Fig. 16). Metal sword reset in lead caulking and appears not to be in original location (Fig. 17), otherwise stonework in reasonable condition.

6. The previously repaired right hand of the statue and sword should be re-examined to determine if it is secure and fixings used are of non-ferrous metal.

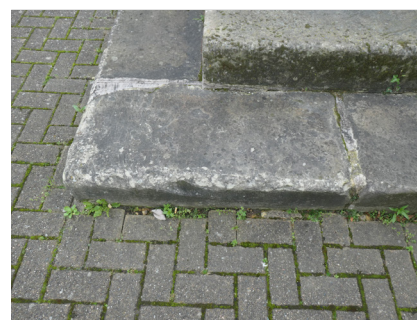
Fig.18 - Spalled edging to steps

Spalled edging to steps with minor lime mortar patch repairs with possible cementitious content (Fig. 18). Steps inadequately bed lapped with voids evident at bedding between steps. 1 no. replacement stone to bottom step (stone type not known). Widespread algae and lichen soiling.

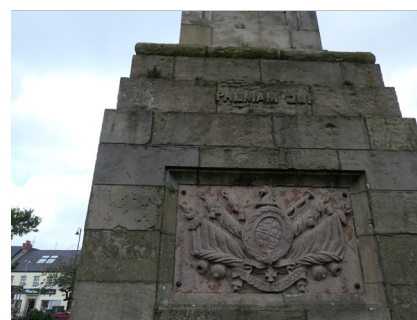
Fig.19 - Surface pitting

Surface pitting throughout (Fig. 19). Contour scaled delamination to 1 no. polished ashlar and minor delamination to moulded string course. Cementitious mortar repairs to 1 no. ashlar stone with fracture evident. Widespread algae and lichen soiling (Fig. 20).

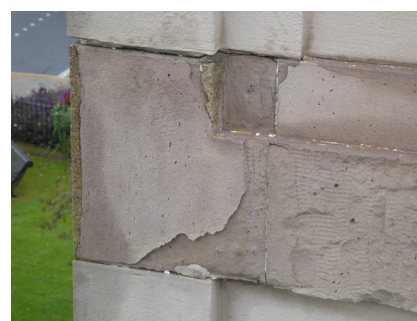
Fig.21 - Delamination

Extensive delamination to stonework at bottom of panel (Fig. 21). Minor pitting and erosion to remainder of panel otherwise reasonable condition.

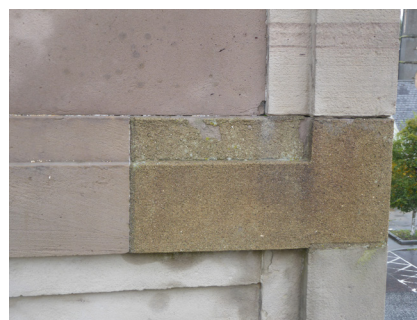
Fig.42 - Cementitious mortar repair

Inappropriate cementitious mortar repair carried out to 1 no. stone below inscribed panel (Fig 42). Minor delamination to 2 no. stones.

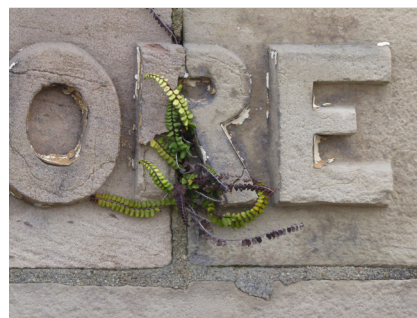
Fig.43 - Open joints with light vegetation

Open joints having light vegetation growth (Fig. 43). Inappropriate cementitious pointing throughout applied over original lime putty, joints widened during previous phase of repairs.

1. All vegetation should be sprayed with a systemic weedkiller during the active growth period in order to fully kill off the plant at root level. This work should ideally be carried out in advance of any stonework repair project.
2. Spalled and fractured stonework – urgent attention is required to high level work which exhibits spalling and fracturing.
3. All delaminated stone should be lightly scraped to remove delaminated layers of stone. All delaminated stone should be lightly trowel scraped and surfaces cleaned with suitable bristle brushes (not wire brushes) or carborundum blocks.
