ARDS AND NORTH DOWN BOROUGH COUNCIL

**GILLESPIE MONUMENT
COMBER**

CONDITION REPORT

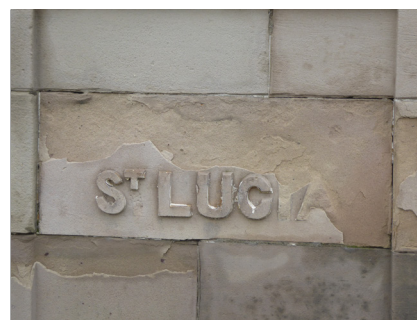
Fig.22 - Partial loss of lettering

Extensive delamination resulting in partial loss of raised lettering, remaining lettering in poor condition (Fig. 22). Inappropriate cementitious mortar repairs carried out stone on west side of panel. Minor fracture to stone below recessed panel.

12. Missing raised lettering inscription could be addressed with new indentation lettering or left alone. Fissured and remnants of raised or incised lettering and relief carvings should be preserved by consolidation treatment in order to stem the weathering process. It is essential this work is carried out by a qualified specialist stone conservator.

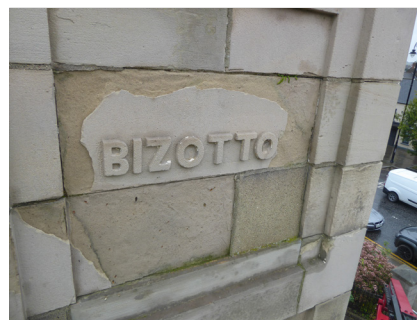
Fig.23 - Extensive delamination

Extensive delamination to recessed panel stonework and quoin to west site of panel, partial loss of raised lettering, remaining lettering subject to further delamination (Fig. 23). Minor fractures and decay to arrises of stone on east side of panel. Inappropriate cementitious mortar repairs carried out, to 2 no. stones, repairs fractured.

4. Delaminated stonework – All delaminated stonework should be individually assessed by a suitably qualified conservation professional for possible retention in order to retain as much of the original fabric, through consolidation, stabilisation or full replacement. Heavily delaminated ashlar stone beyond repair should be replaced using a compatible stone type.

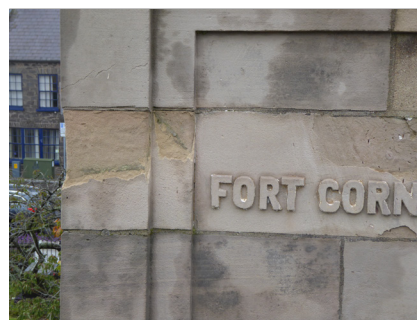
Fig.24 - Extensive delamination

Inappropriate thinly applied cementitious mortar repairs carried out to 2 no. stones. Extensive delamination to lettered stone and quoin to west side of panel. Minor fracture to quoin to west side of panel (Fig. 24).

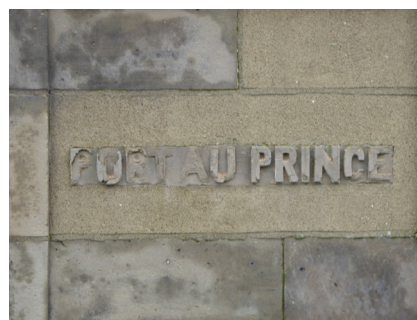
Fig.25 - Partial loss of lettering

Inappropriate thinly applied cementitious mortar repairs carried out to 2 no. stones and lettered stone resulting in partial loss of raised lettering, remaining lettering in poor condition (Fig. 25). Delamination to east quoins. Minor pitting.

3. Cementitious render repairs – These should be removed and underlying stone accessed individually by a suitably qualified conservation professional for indentation repair or full replacement using a compatible stone type.

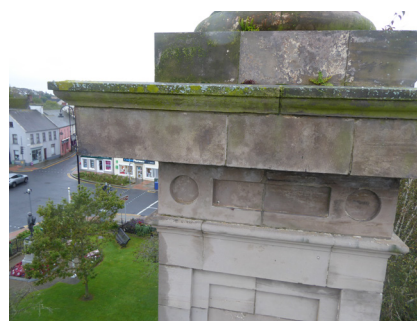
Fig.26 - Algae staining

Algae staining (Fig. 26), minor erosion, fractured stone, otherwise reasonable condition.

1. Stone cleaning – Algae and moss should be removed using an environmentally friendly biocide coupled with a light steam low pressure wash to remove staining.

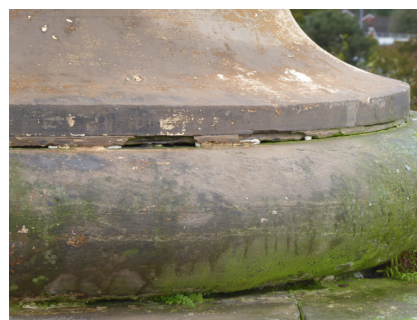
Fig.27 - Fracture

Heavy algae staining. Fracture between joint of statue and upper base stone with delamination of base bed, possibly indicating movement, otherwise stonework in reasonable condition (Fig. 27).

5. The fixing to the statue should be examined by a structural engineer to ensure that it is intact and fit for purpose. Some cracking around the base and surface corrosion on the exposed ferrous metal bar may indicate possible movement. It may be necessary to remove the statue and replace the fixing with 304 marine grade stainless steel threaded bar and bolt.

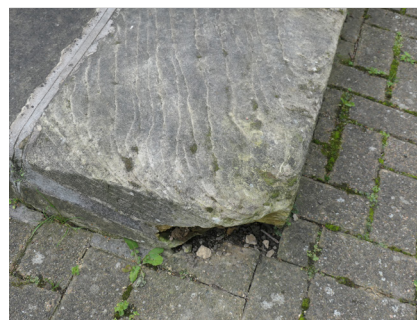
Fig.28 - Advanced decay of stone step

Spalled edging to steps. Steps inadequately bed lapped with minor open joints revealing possible voids between steps. 1 no. replacement stone to bottom step (stone type not known), extensive delamination and decay to north end of bottom step (Fig. 28). Widespread algae and lichen soiling.

2. Undermined and heavily delaminated step to plinth should be replaced with a suitable stone replacement and any displaced stonework eased back into position.

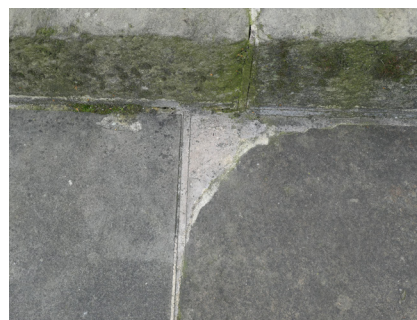
Fig.29 - Putty lime pointing

Putty lime pointing with possible cementitious content. Pointing excessively applied over worn arrises (Fig. 29).

8. All defective and inappropriate cement-based pointing should be raked-out using non-mechanical means and repointed using lime-based mortar. This will entail full repointing of the entire monument.

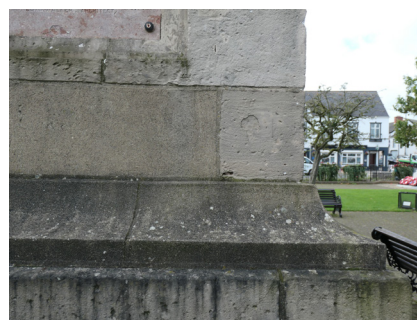
Fig.30 - Surface pitting

Surface pitting throughout (Fig. 30). Minor contour scaled delamination to 1 no. polished ashlar. Cementitious mortar repairs to 2 no. moulded string course and patch repair to south end. Widespread algae and lichen soiling.

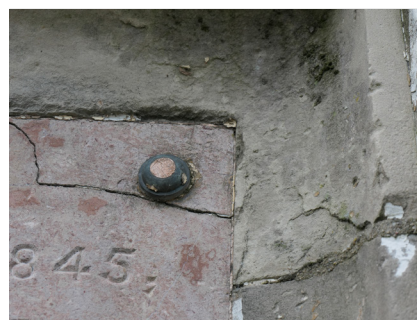
Fig.31 - Fracture on limestone tablet

Minor erosion to inscribed limestone tablet, metal fixings heavily corroded, fracture upper north corner, otherwise reasonable condition (Fig. 31).

7. Limestone tablets – Relief carvings and incised lettering should be lightly cleaned and all fixings carefully removed and refixed with stainless steel fixings. Fractured panel should be repaired with epoxy resin. A low pressure lime based grout should be used to fill voids behind each tablet.

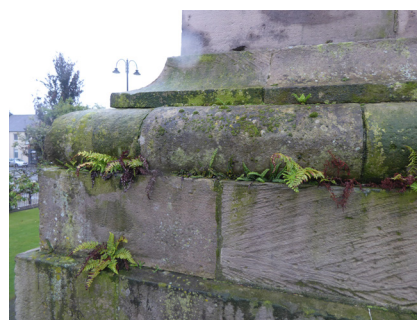
Fig.32 - Vegetation growth in open joints

Open joints between statue, base and moulded frieze. Light vegetation growth in open joints.

1. All vegetation should be sprayed with a systemic weedkiller during the active growth period in order to fully kill off the plant at root level. This work should ideally be carried out in advance of any stonework repair project.
2. Spalled and fractured stonework – urgent attention is required to high level work which exhibits spalling and fracturing.
3. All delaminated stone should be lightly scraped to remove delaminated layers of stone. All delaminated stone should be lightly trowel scraped and surfaces cleaned with suitable bristle brushes (not wire brushes) or carborundum blocks.

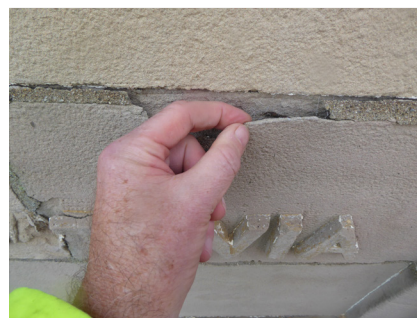
Fig.33 - Advanced decay of stone

Advanced decay to inscribed panel stones resulting in partial loss of raised lettering (Fig. 33).

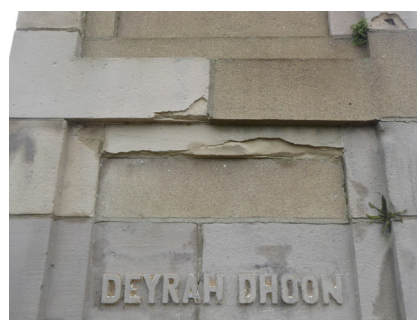
Fig.35 - Delamination

Widespread inappropriate thinly applied cementitious mortar repair above inscribed panel. Delamination to stonework surrounding cementitious repair (Fig. 35). Fractured bed to stone below inscribed panel.

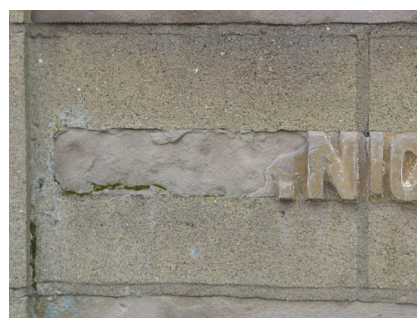
Fig.36 - Loss of raised lettering

Widespread inappropriate thinly applied cementitious mortar repairs resulting in loss of raised lettering (Fig. 36), minor delamination decay to several stones.

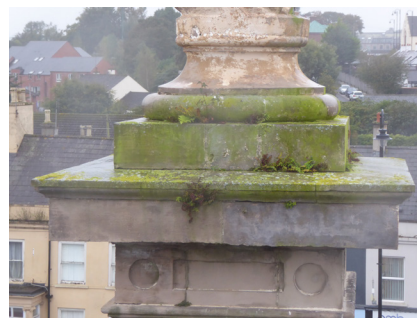
Fig.37 - Heavy algae staining

Heavy algae staining (Fig. 37), minor spall marks having mortar infill, otherwise stonework in reasonable condition.

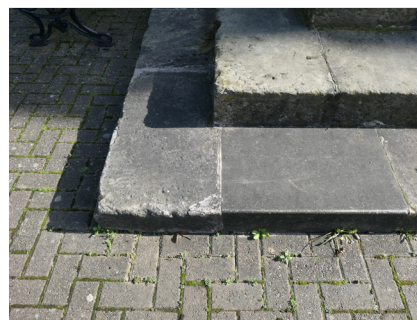
Fig.38 - Spalled edging to steps

Spalled edging to steps (Fig. 38). Steps inadequately bed lapped with minor open joints revealing possible voids between steps. 2 no. replacement stones to bottom step (stone type not known). Patch repair to central bottom step with metal rail stub (Fig. 39). Minor algae and lichen soiling.

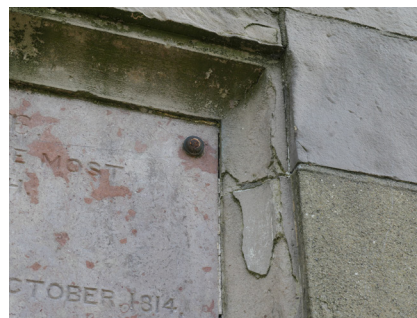
Fig.40 - Delamination

Heavily worn with surface pitting throughout. Extensive cementitious mortar repairs carried out to face of 1 no. ashlar stone and 5 no. quoin stones. Extensive contour scaled delamination to moulded border surrounding recessed panel and minor scaling throughout (Fig 40). Minor algae and lichen soiling.

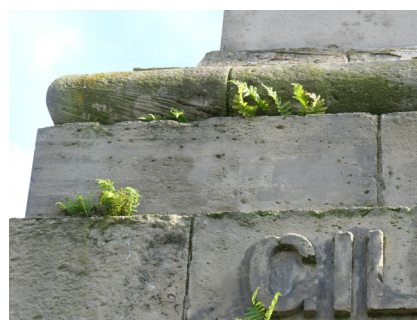
Fig.41 - Algae and vegetation in open joints

Extensive delamination to upper moulded surface. Minor algae soiling with light vegetation growth in open joints and ledges (Fig. 41).

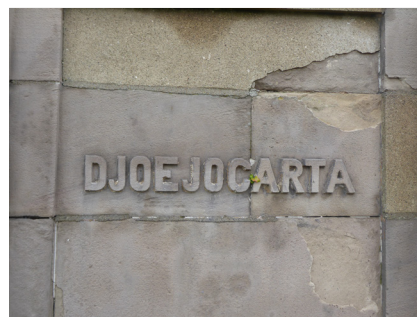
Fig.44 - Delamination

Widespread inappropriate thinly applied cementitious mortar repair above and to south side of inscribed panel. Delamination to stonework surrounding cementitious repair and to north side of panel (Fig. 44). Fractured stone below inscribed panel.

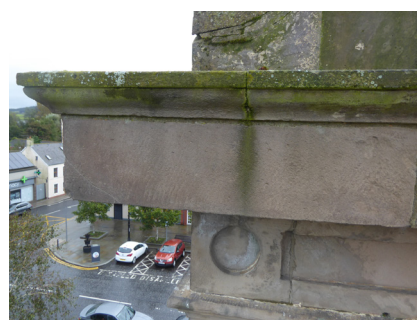
Fig.45 - Fracture

Fracture to north end of west face presenting a potential safety hazard (Fig. 45), algae staining, otherwise reasonable condition.

1. Remove all dangerously loose stone as highlighted throughout the report.

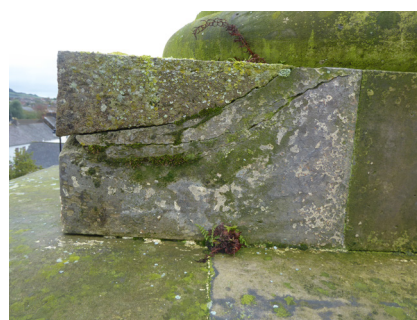
Fig.46 Heavily fractured stone

Heavy algae staining, heavily fractured stone to north-west corner (Fig. 46), otherwise stonework in reasonable condition.

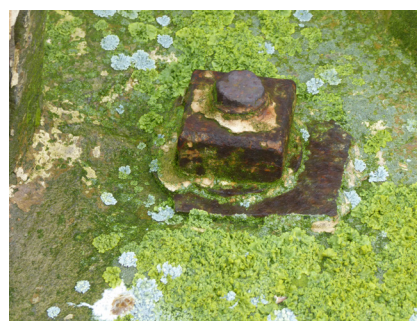
Fig.47 - Metal bolt

Heavy algae staining. Metal bolt and threaded bar fixing of statue to base exposed (Fig. 47), light corrosion evident. Fractured right hand as described on north elevation, otherwise stonework in reasonable condition.

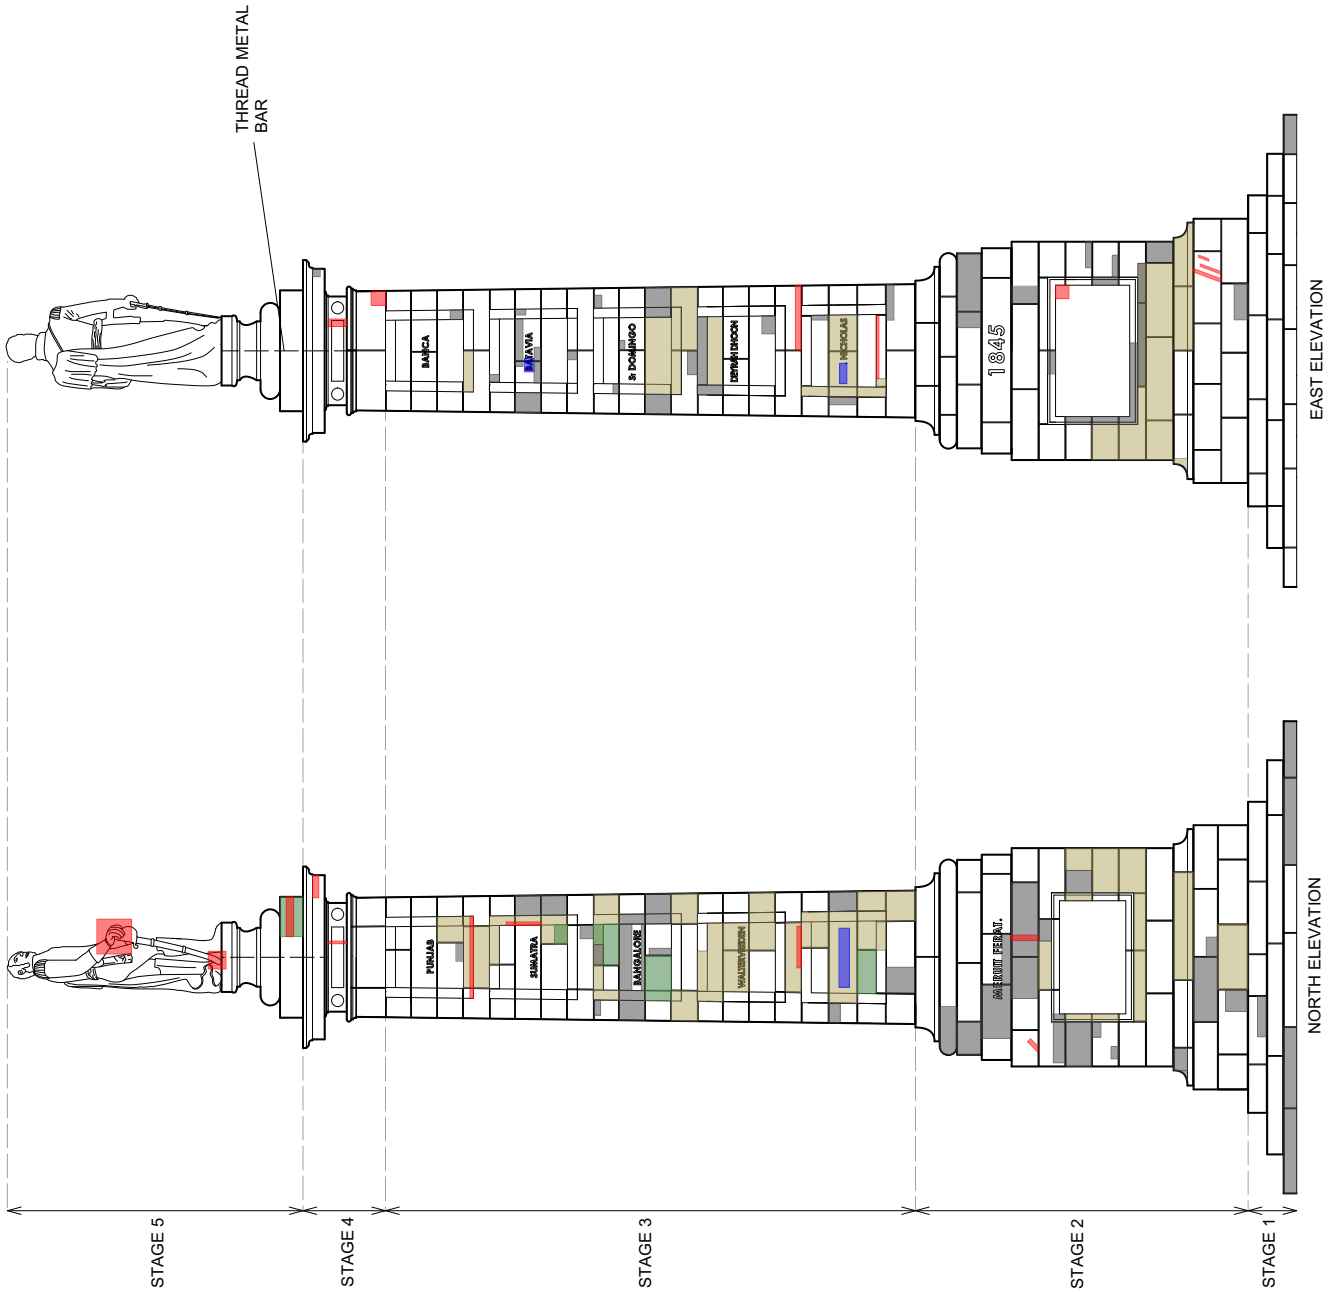
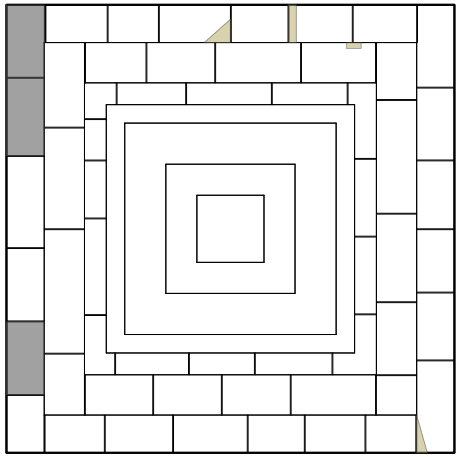
PLAN VIEW TO SHOW DAMAGE TO STEPS

- ADVANCED DECAY
- DELAMINATION
- CEMENTITIOUS MORTAR REPAIRS
- FRACTURES
- MISSING / DAMAGED LETTERING
